# Transportation Research Division

## Technical Report 05-08

*Utilizing Lignosulfonates for Gravel Shoulder  
Stabilization*

*Construction, First, and Second Interim Report  
September, 2007*

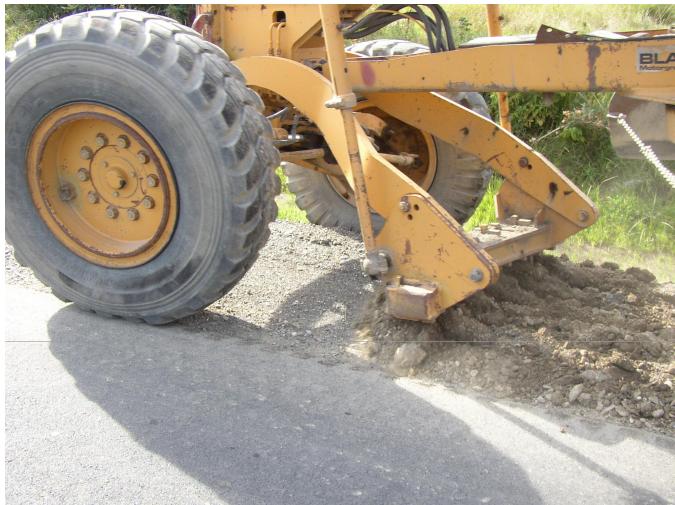
Photo 1 Scarifying Compacted Shoulder Gravel

While scarifying the north bound shoulder it was apparent that there were a number of large pieces of compacted gravel left behind. This can be seen in Photos 1 and 2. To get good stability it's necessary to coat the gravel completely, in particular fine grain material that passes the 200 sieve. In order to get proper TDS penetration, the grader made a second pass with the blade to break up the large gravel pieces. This procedure worked quite well and was used to scarify the remaining shoulders. It took three days to complete stabilization of the shoulders.

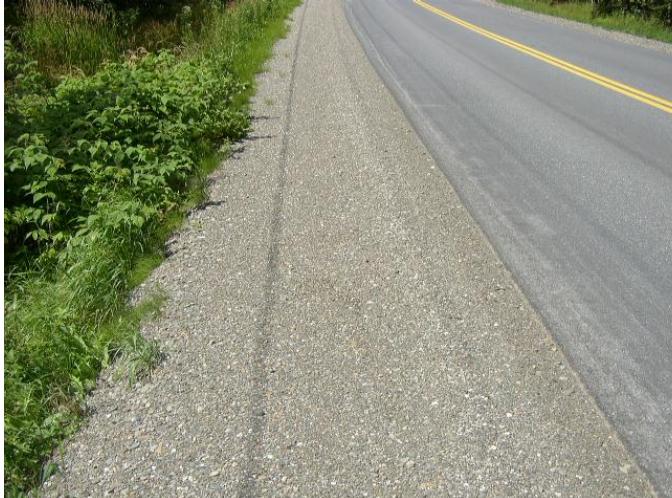
Photo 7 PIN 11538.00 Experimental Section

The experimental section looks very good with no erosion or vegetation on the shoulders as displayed in Photo 7. The gravel shoulder is even with the pavement surface and the gravel surface is very firm.

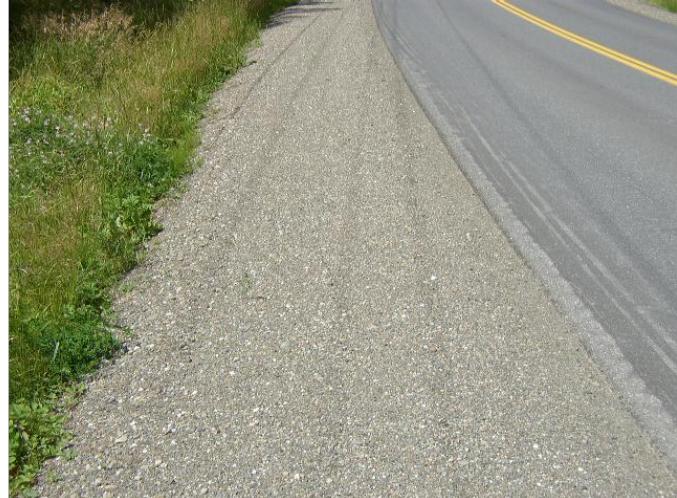
Photo 8 PIN 11538.00 Control Section

The Control Section has no erosion and no vegetation. The gravel is even with the roadway as displayed in Photo 8.

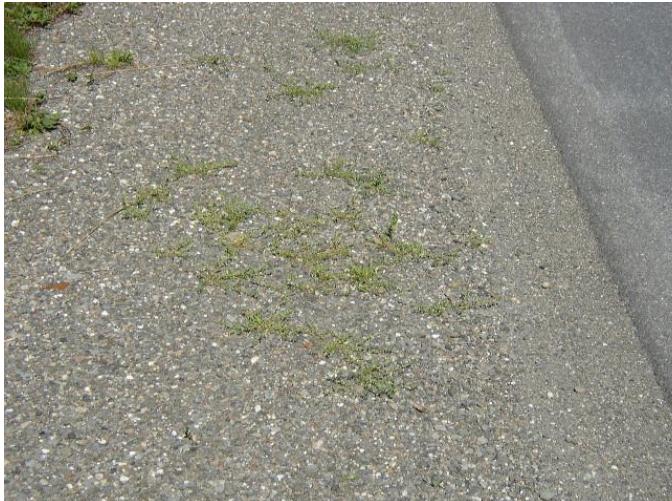
Photo 9 Experimental Section Vegetation

The Experimental Section is in very good condition. A small amount of vegetation is beginning to grow on the shoulder as displayed in Photo 9. There is an elevation change of 0.5 inches between the shoulder and pavement. It appears that a portion of the untreated shoulder gravel that was placed after the project was surfaced with HMA has eroded away as displayed in Photo 10. The gravel shoulder feels solid under foot.

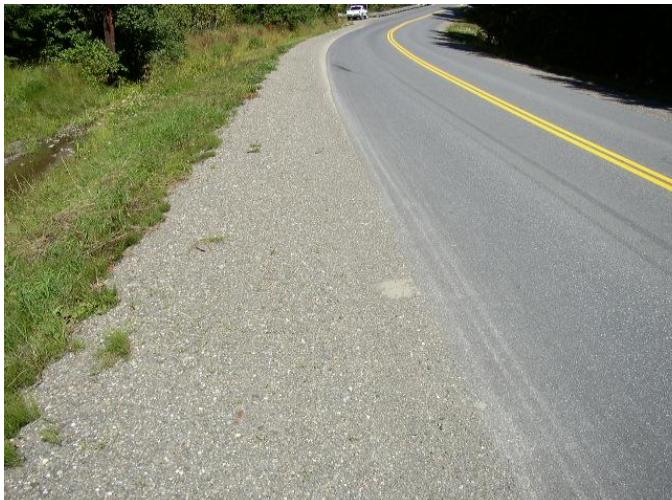
Photo 11 Control Section

The Control Section is in very good condition with less vegetation than the Experimental Section as displayed in Photo 11. Shoulder gravel elevation is 1.0 inch below the pavement. This Section is located on an outside curve and it appears that the elevation change is caused by traffic riding on the shoulder as displayed in Photo 12.

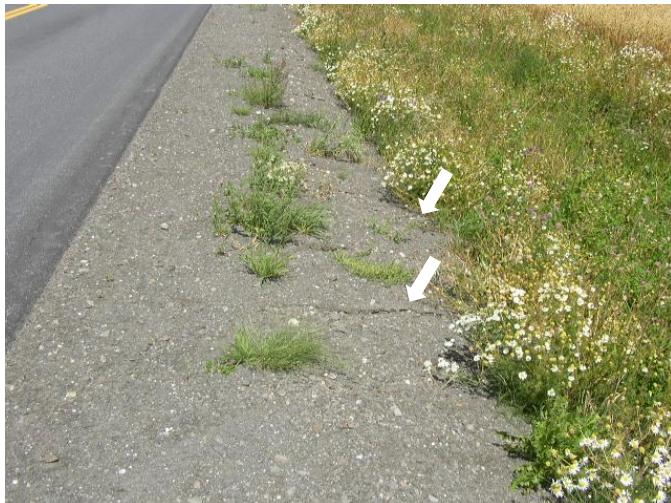
Photo 13 Experimental Section Erosion Lines

There are many areas within the Experimental Section that have erosion lines. Erosion lines begin 3.5 feet from the edge of pavement and run from that point to the ditch line and are between 2 and 3 inches deep as displayed in Photo 13. Photo 14 displays vegetation growing on the shoulders and there is a 0.5 inch elevation change between shoulder and pavement. It appears that the gravel shoulder is stable from the pavement edge to roughly 3 feet from the edge. The project resident stated that they had moderate rains shortly after the shoulders were treated and the TDS may not have had enough time to cure. Another issue is the amount of fines in the shoulder gravel. This project has 3.5 percent passing the # 200 sieve whereas the Madawaska project has 8.0 percent. The TDS representative stated that he typically likes to work with soils that have 10 percent or greater passing the # 200 sieve.

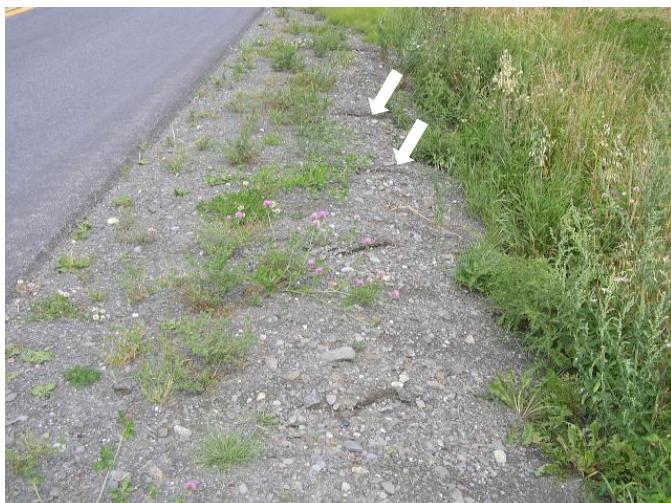
Photo 15 Control Section Erosion Lines

The Control Section has more erosion and vegetation than the Experimental Section. The erosion pattern is similar but the erosion lines begin roughly 2.5 feet away from the pavement edge as displayed in Photo 15. Vegetation has covered considerably more shoulder area as displayed in Photo 16.

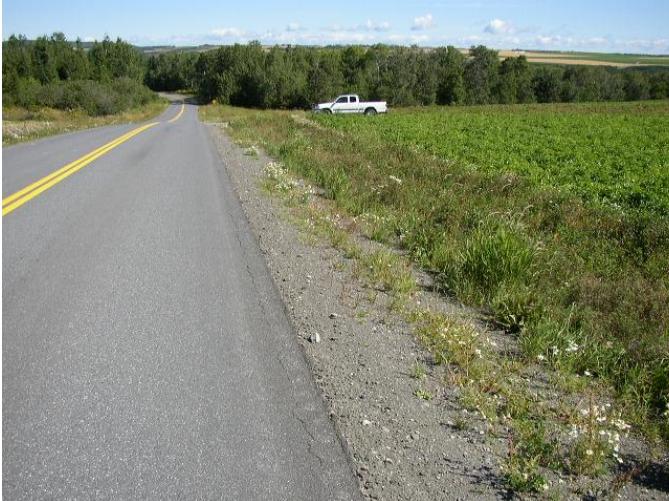
Photo 17 Experimental Section Vegetation

The Experimental Section has less visible erosion and more vegetation than last year is shown in Photo 17. The MaineDOT Maintenance Division re-graded the shoulders in early 2007. The gravel is 1.0 to 1.5 inches below pavement elevation as shown in Photo 18.

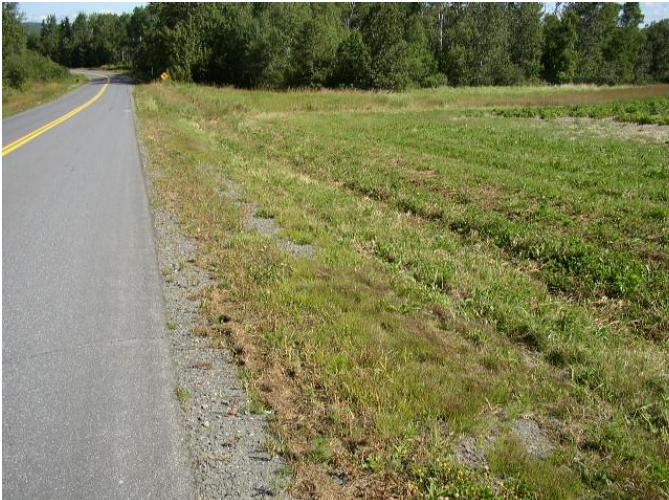
Photo 19 Control Section Vegetation

The Control Section is almost completely covered with vegetation as displayed in Photo 19. The amount of erosion is similar to the Experimental Section and the elevation change is between 1.5 and 2.0 inches deep as displayed in Photo 20.
